PRELIMINARY SITE EVALUATION REPORT

**Remedial Investigation/Feasibility Study
Eagle Zinc Company Site,
Hillsboro, Illinois**

**ENVIRON International Corporation
Deerfield, Illinois**

March 2002

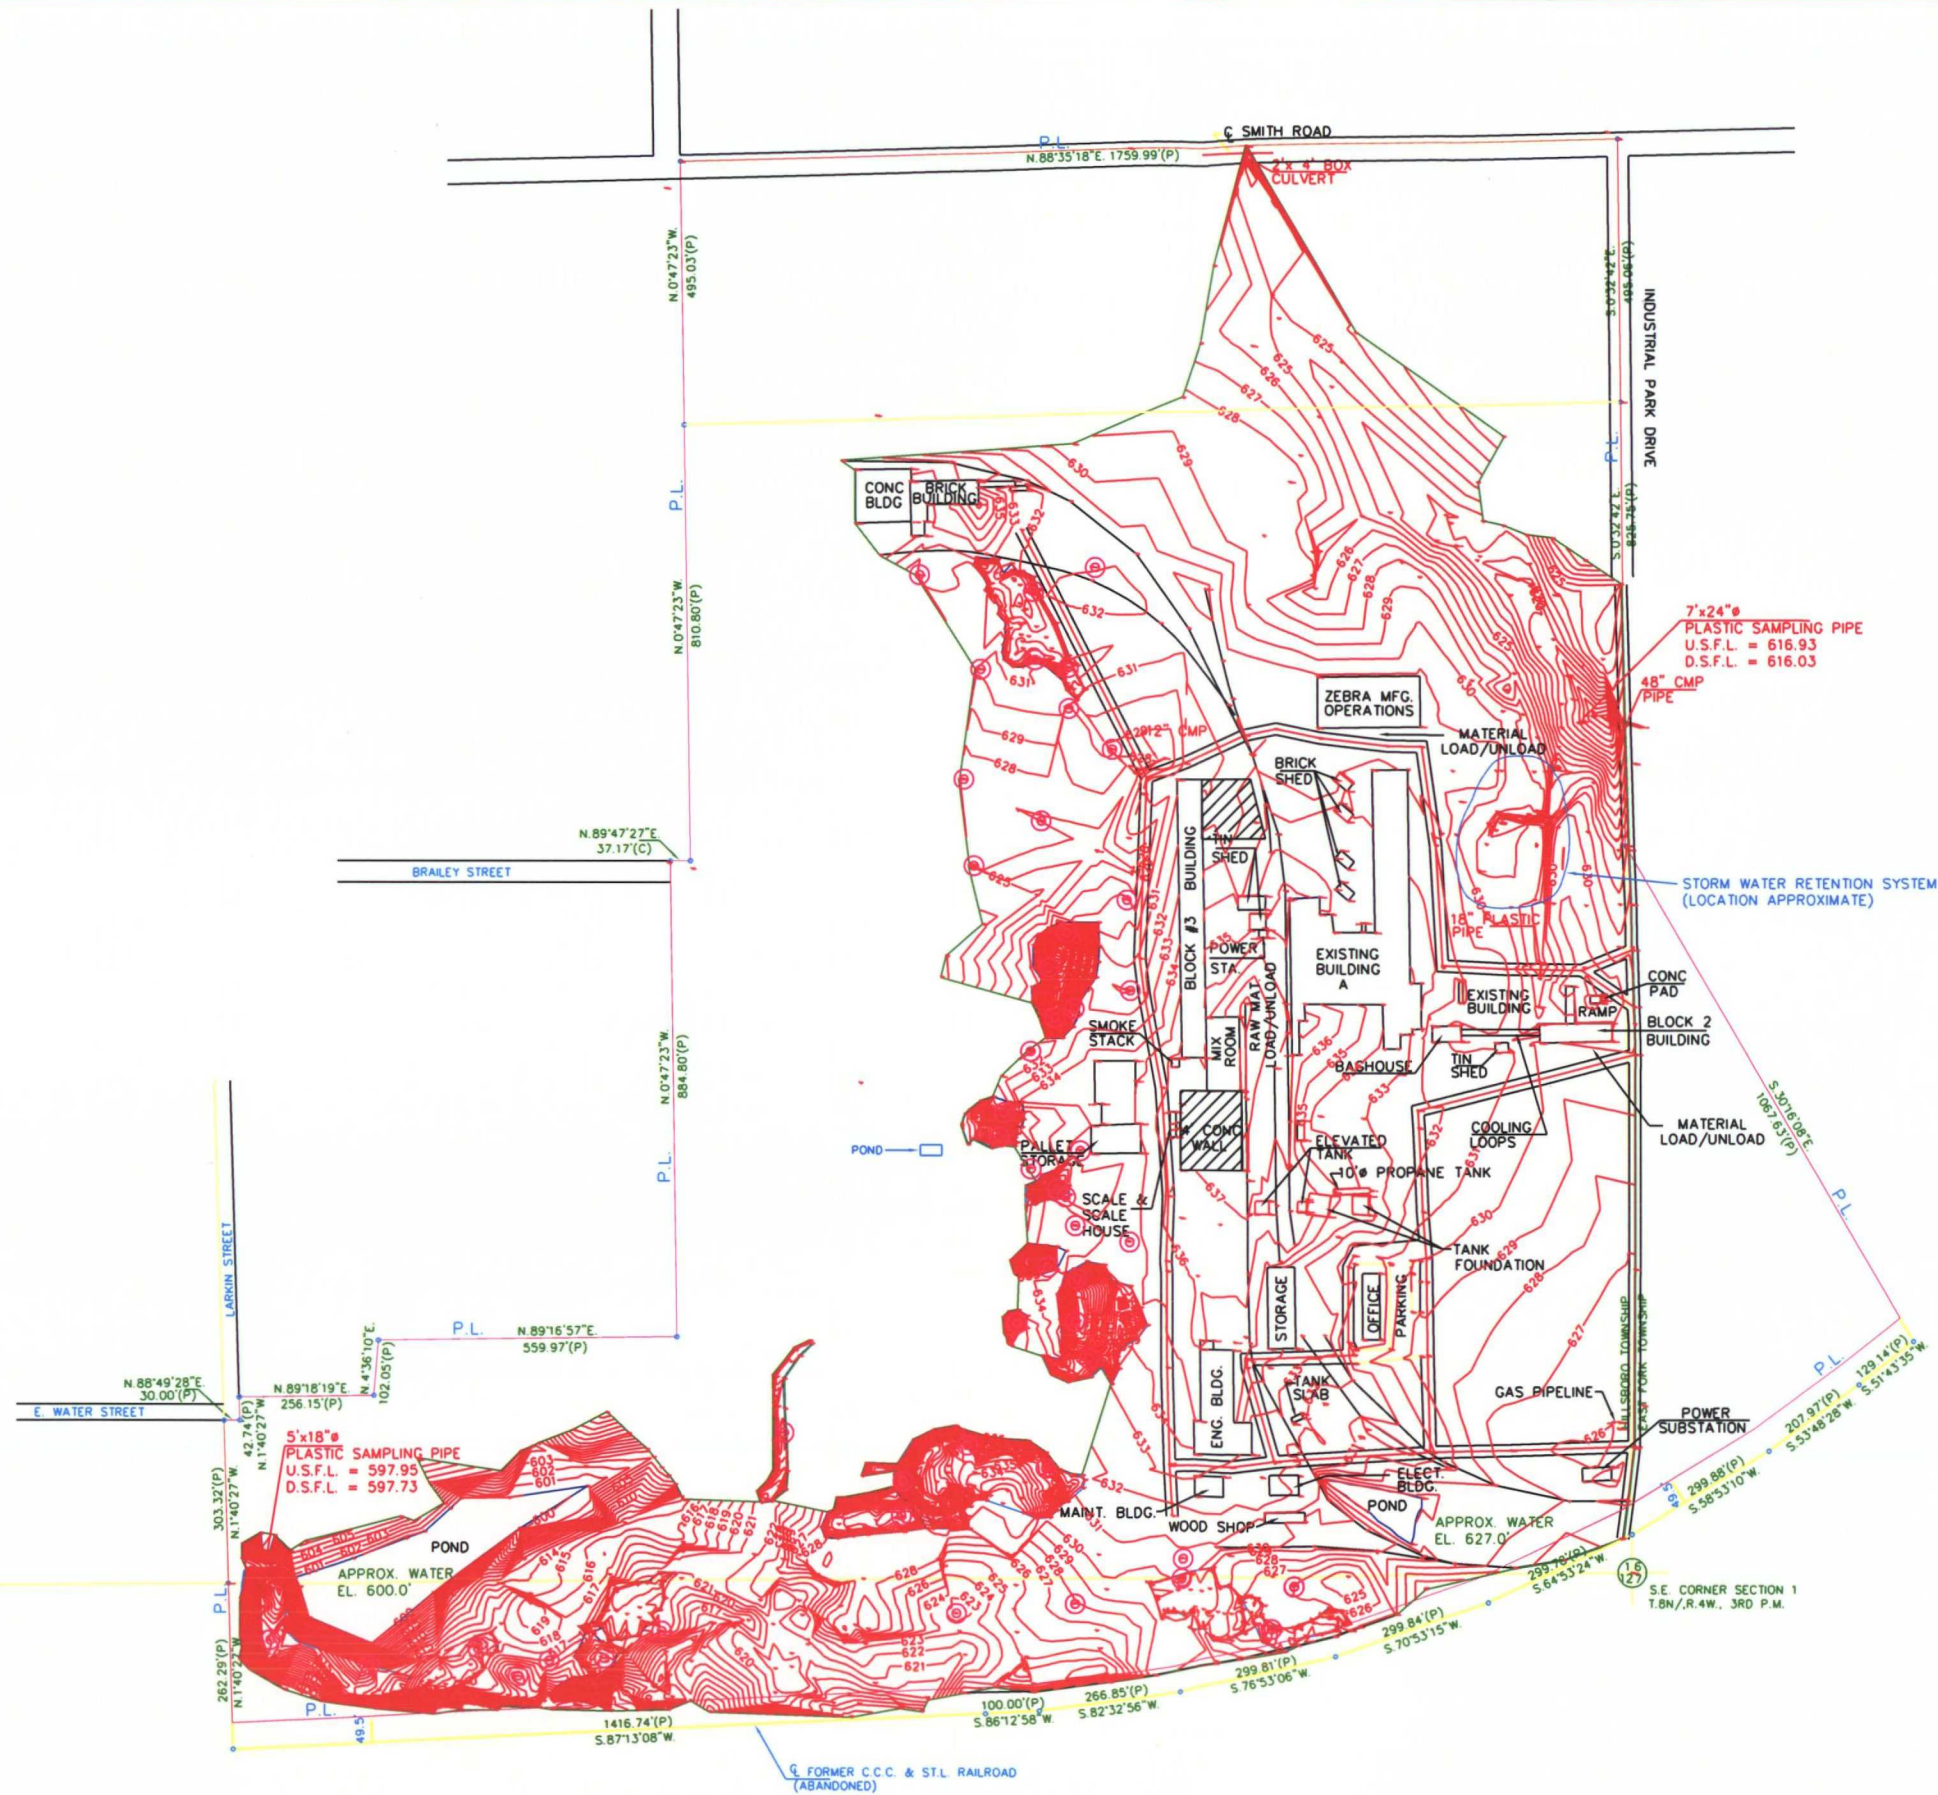
FIGURE
3

The surface topography of the Site is relatively level, with surface elevations ranging from about 600 feet above mean sea level (msl) at the southwest retention pond to about 635 feet above msl in the central portion of the Site. The predominant topographic slope of the Site is southerly. Three surface water ponds exist at the Site: a southwestern storm water retention pond; an engineered storm water retention pond located near the eastern Site property boundary; and a small pond located in the southeastern part of the Site. The southwestern storm water pond receives a large proportion of the Site's storm water runoff. Storm water intermittently discharges westward from this pond to a drainage swale, which in turn discharges to an unnamed intermittent tributary of Middle Fork Shoal Creek. This outfall is permitted with the Illinois Environmental Protection Agency (IEPA) Division of Water Pollution Control as National Pollutant Discharge Elimination System (NPDES) Outfall 001. Middle Fork Shoal Creek Flows southwestward and joins Shoal Creek approximately 6 miles southwest of the Site.

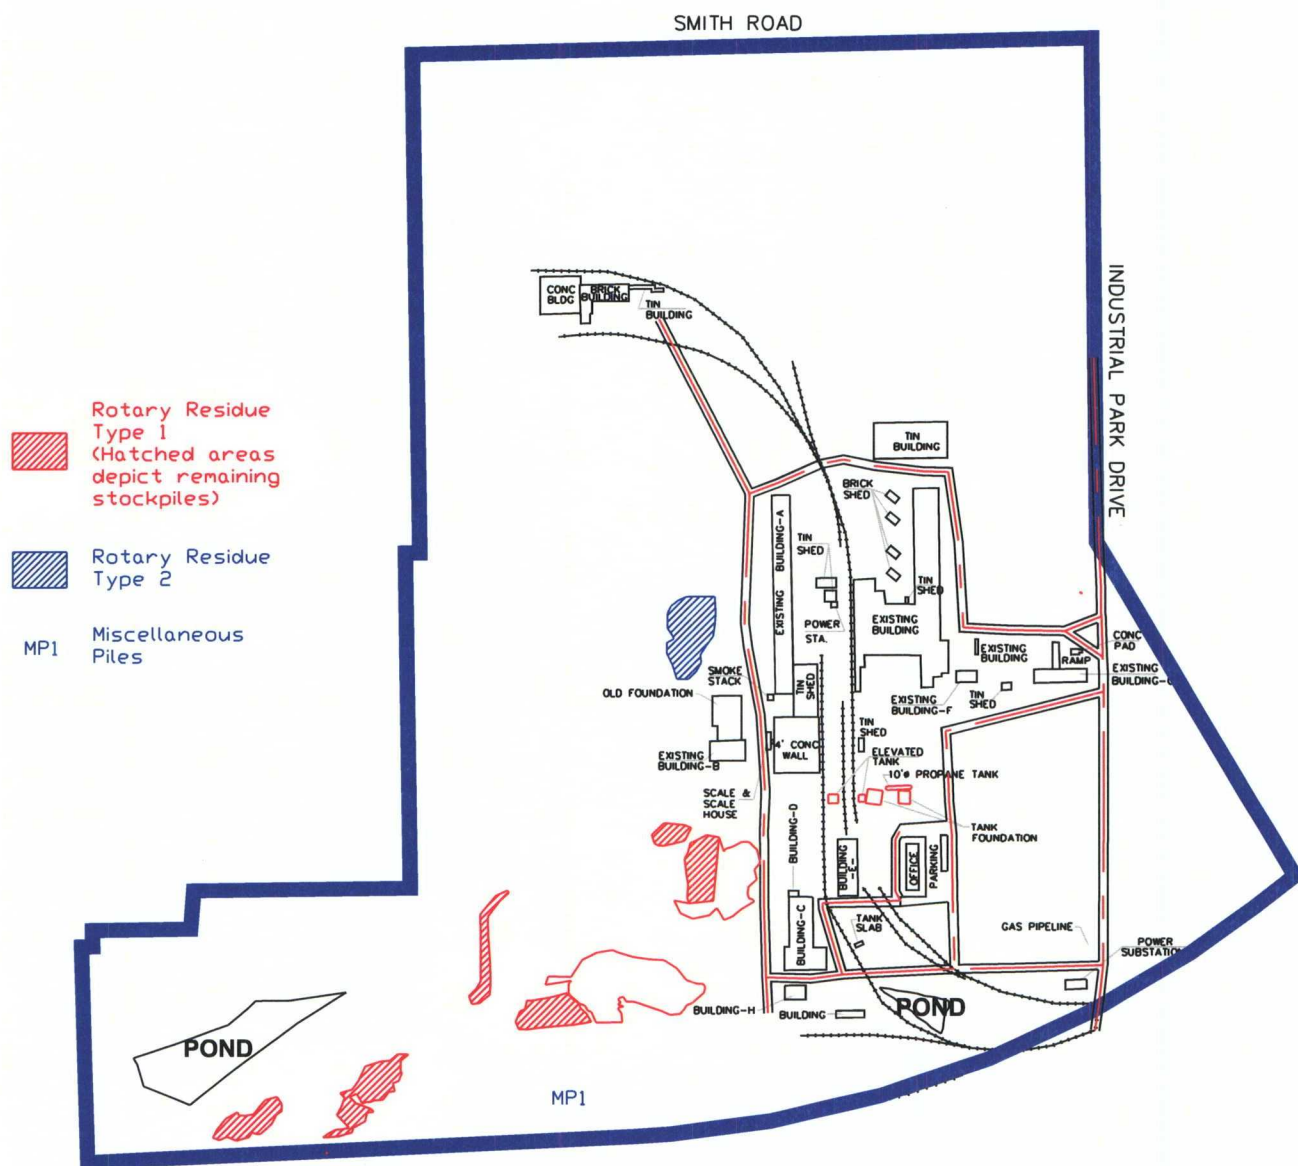
Figure
12

Potential Areas of Concern
Residues
Eagle Zinc, Hillsboro, Illinois

Two samples of residue piles, designated X-103 and X-105, were collected by IEPA as part of the 1993 Expanded Site Inspection and 68 samples of residue piles were collected by GBI in May 1998, with split samples collected by IEPA. The samples collected by IEPA in 1993 were analyzed for TCL inorganics; the samples collected by GBI in May 1998 were analyzed for lead and cadmium, with selected samples analyzed for TCLP lead and TCLP cadmium. The residue samples collected by GBI represented 15 discrete stockpiles that were categorized as the following types: RRO (Rotary Residue Oversize); RR1 (Rotary Residue Type 1); RR2 (Rotary Residue Type 2); RCO (Rotary Clean Out); CPH (Carbon Plant Hutch); and MP (Miscellaneous Piles).

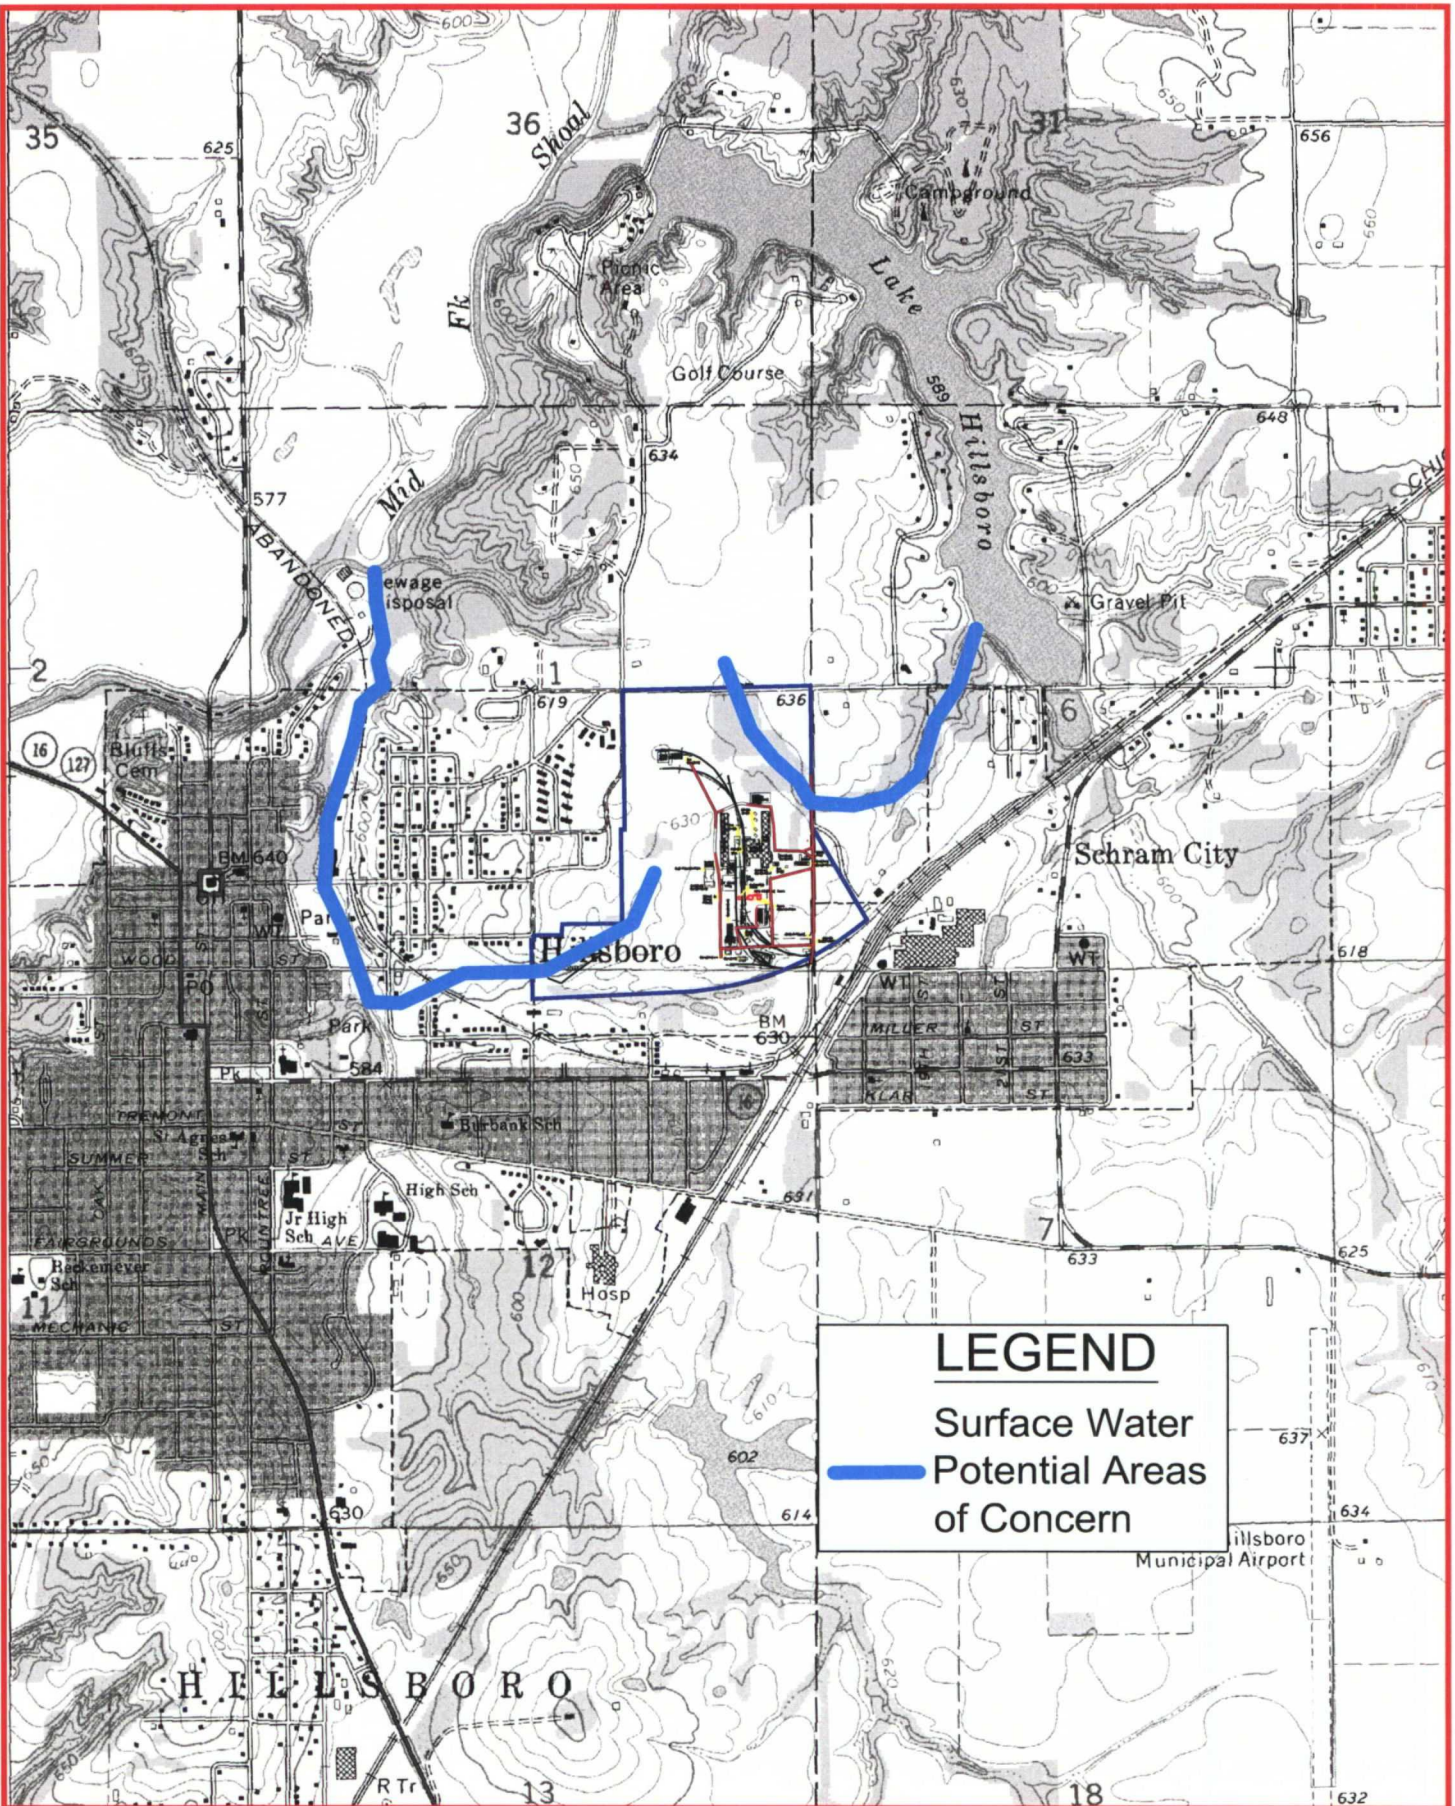
Figure
13

Potential Areas of Concern
Surface Water
Eagle Zinc, Hillsboro, Illinois

The locations of the previous storm water samples, Outfall 001 and Outfall 002, are shown on Figure 9. The analytical results are summarized in Table 6. For screening purposes, the storm water data were compared with Illinois Water Quality Standards: 35 IAC 302 Subpart B (General Water Quality Standards), and 35 IAC 302 Subpart D (Secondary Contact and Indigenous Aquatic Life Standards). It should be noted that these criteria are statewide standards and are not effluent limitations specific to the facility's NPDES permit.

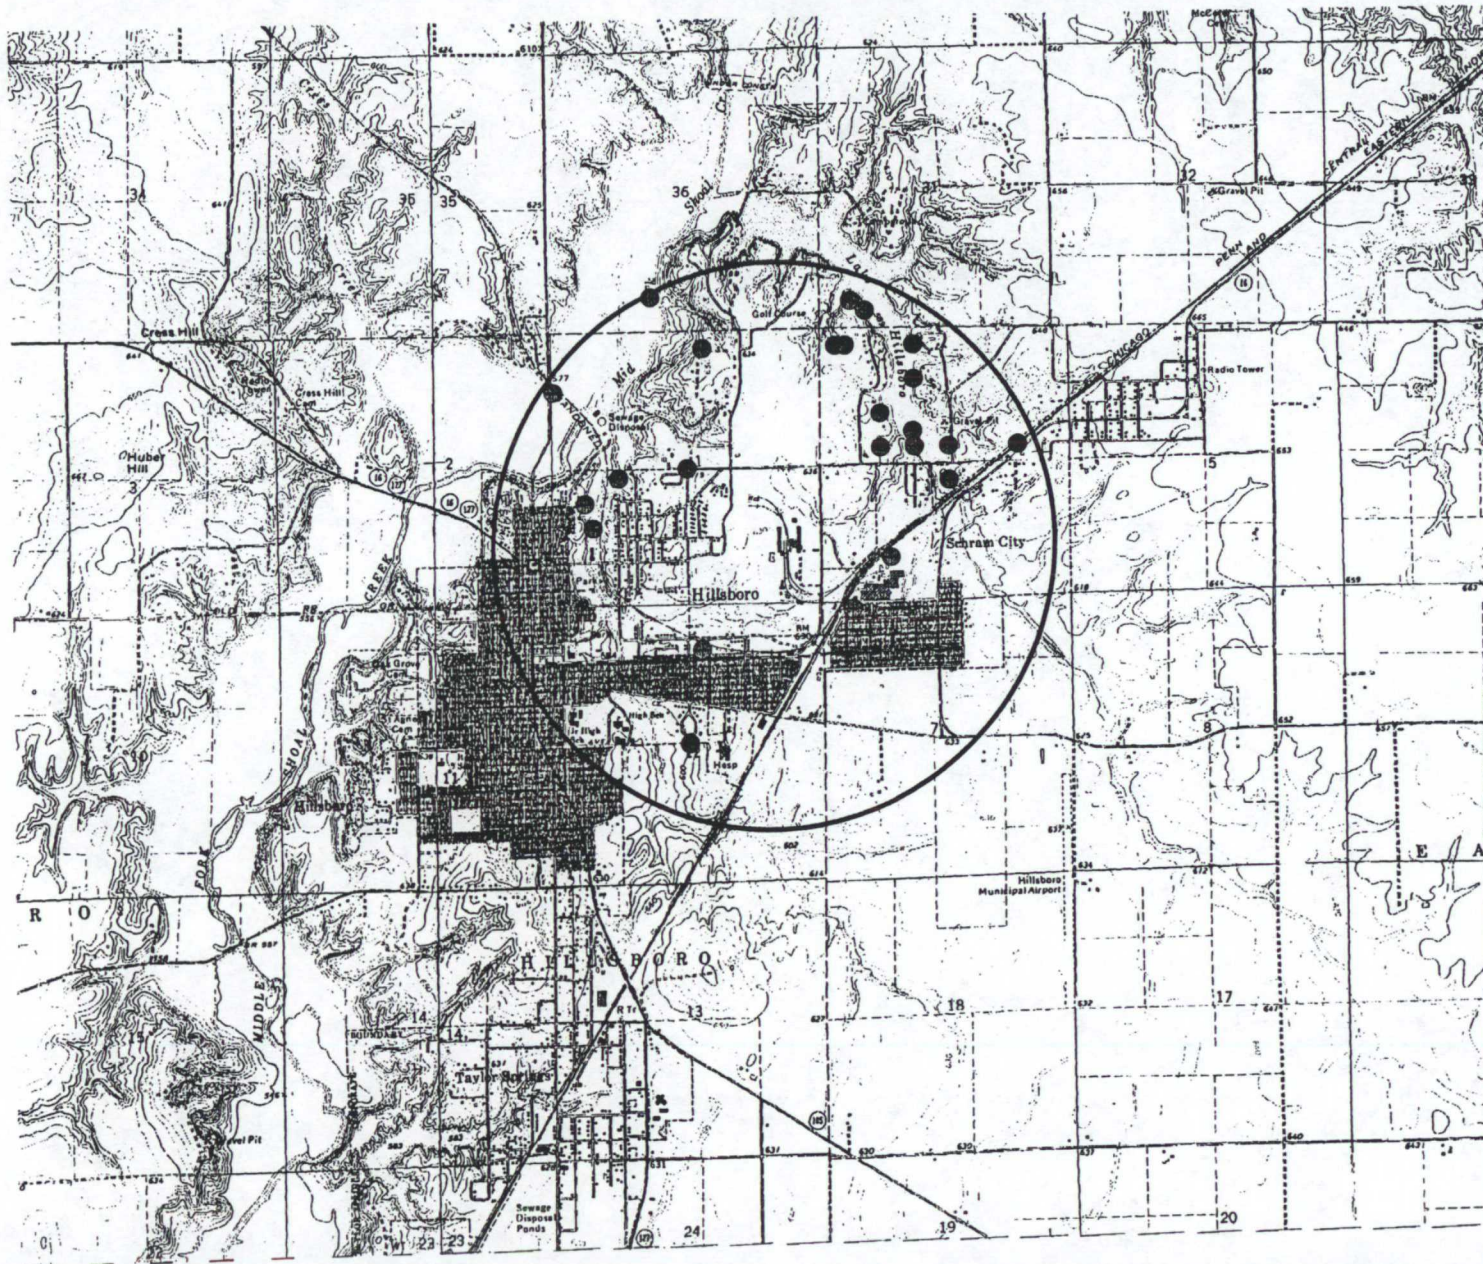
One Mile Well Search Eagle Zinc Hillsboro, Illinois

● Well Locations
□ One Mile Radius

ENVIRON submitted a request to the IEPA for a 1-mile radius search of potential water supply wells and conducted an on-line search of well records maintained by the Illinois Department of Natural Resources (IDNR). The IEPA's Department of Public Water Supply reported that no community water supply wells are located within 2,500 feet of the Site boundaries. Several domestic wells were reported by the Illinois State Water Survey (ISWS) as being located within a one-mile radius of the Site. The well search results, including the IDNR well records and ISWS one-mile radius plot, are included in Attachment A.

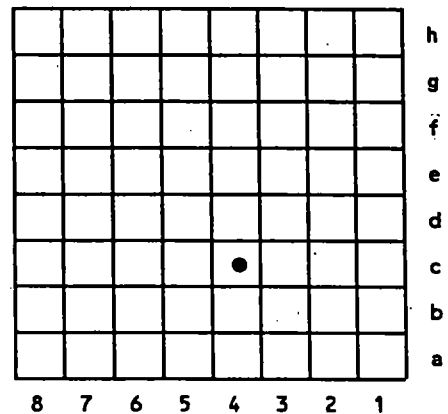
The location system uses Township, Range, and Section. The location consists of five parts: County abbreviation, Township, Range, Section, and coordinate within the section (subsection or 10-acre plot). Sections are divided into rows of 1/8-mile squares. Each 1/8-mile square contains 10 acres and corresponds to a quarter of a quarter of a quarter section. A normal section of 1 square mile contains 8 rows of 1/8-mile squares; an odd-sized section contains more or fewer rows. Rows are numbered from east to west and lettered from south to north as shown in the diagram.

The location of the well shown above is 163 2N10W-23.4c. The well point is located at the center of this 10-acre plot.

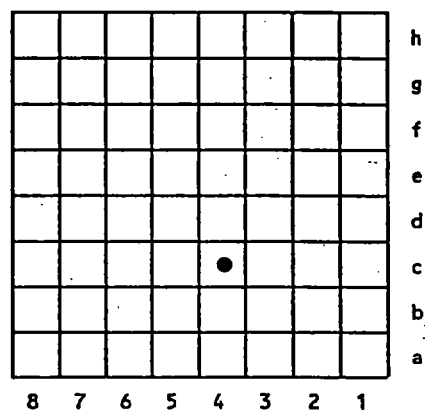
The location system uses Township, Range, and Section. The location consists of five parts: County abbreviation, Township, Range, Section, and coordinate within the section (subsection or 10-acre plot). Sections are divided into rows of $\frac{1}{8}$ -mile squares. Each $\frac{1}{8}$ -mile square contains 10 acres and corresponds to a quarter of a quarter of a quarter section. A normal section of 1 square mile contains 8 rows of $\frac{1}{8}$ -mile squares; an odd-sized section contains more or fewer rows. Rows are numbered from east to west and lettered from south to north as shown in the diagram.

The location of the well shown above is 163 2N10W-23.4c. The well point is located at the center of this 10-acre plot.
